**Flood Control Project Maintenance  
Levee Inspections**

## Maintenance Issue Types Only, Levee Inspection Report By Mile - Spring 2015

### Sutter Maintenance Yard Maintenance Area 0013

Waterway	Bank	Unit Miles	Inspection Start/End	Inspector
Unit No. 01 Cherokee Canal	Right	18.61	05/06/2015 05/06/2015	Bob Duffey

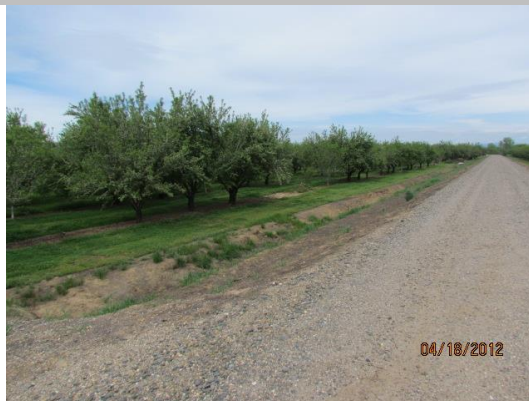
Photo 1 of 1 : SP\_2015\_MA0013\_300\_19\_20150310\_00009.jpg

View of the vehicle erosion along the waterside slope.

LM Start	0.57	Rating **	M	Issue No.	19
LM End	0.57	Issue Type +	Ma	Location *	WS
Category	Earthen Levee			GPS Latitude/Longitude	
				Start	End
Item	Slope Stability			39.590173 °	39.590173 °
				-121.700617 °	-121.700617 °
DWR ID	DWR_MA0013_01_s_2013_19				
Action/Comments					
Repair the levee slope damaged by vehicle traffic and prevent access where possible.

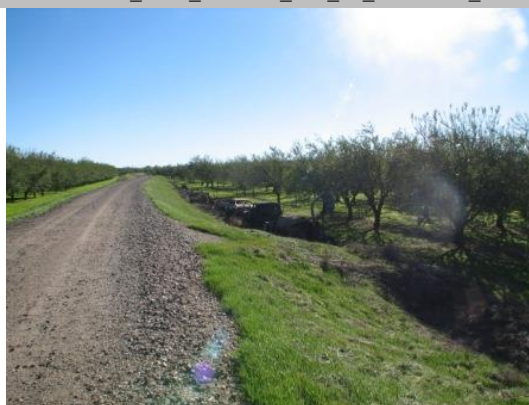
Photo 1 of 1 : SP\_2015\_MA0013\_300\_12\_20150310\_00006.jpg

View of the equipment along the landside toe of the levee.

LM Start	0.73	Rating **	M	Issue No.	12
LM End	0.76	Issue Type +	Ma	Location *	LS
Category	Earthen Levee			GPS Latitude/Longitude	
				Start	End
Item	Encroachments			39.587905 °	39.587505 °
				-121.700822 °	-121.700880 °
DWR ID	DWR_MA0013_01_s_2012_12				
Action/Comments					
Equipment

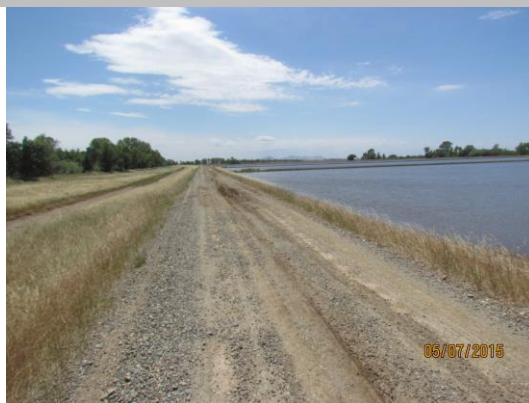
Photo 1 of 1 : SP\_2015\_MA0013\_300\_47\_20150519\_00016.jpg

View of the ruts in the crown roadway.

LM Start	4.45	Rating **	M	Issue No.	47
LM End	5.35	Issue Type +	Ma	Location *	CR
Category	Earthen Levee			GPS Latitude/Longitude	
				Start	End
Item	Crown Surface / Depressions / Rutting			39.536017 °	39.523020 °
				-121.707705 °	-121.707577 °
DWR ID	DWR_MA0013_01_s_2015_47				
Action/Comments					
Repair depressions or ruts in the crown or slope.					
Inspector Comments: Repair the ruts in the crown roadway.

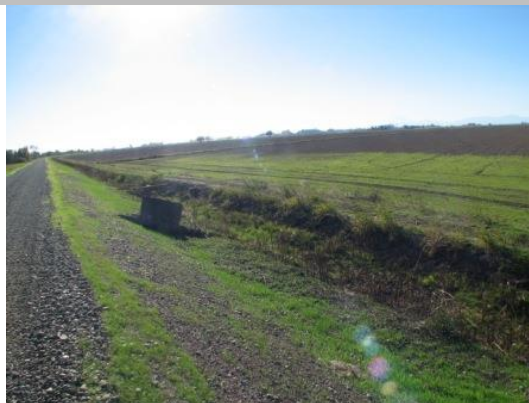
Photo 1 of 1 : SP\_2015\_MA0013\_300\_2\_20150310\_00001.jpg

View of a concrete block along the toe.

LM Start	6.53	Rating **	M	Issue No.	2
LM End	6.53	Issue Type +	Ma	Location *	LS
Category	Earthen Levee			GPS Latitude/Longitude	
				Start	End
Item	Encroachments			39.507337 °	39.507337 °
				-121.715693 °	-121.715693 °
DWR ID	DWR_MA0013_01_s_2012_2				
Action/Comments					
Material

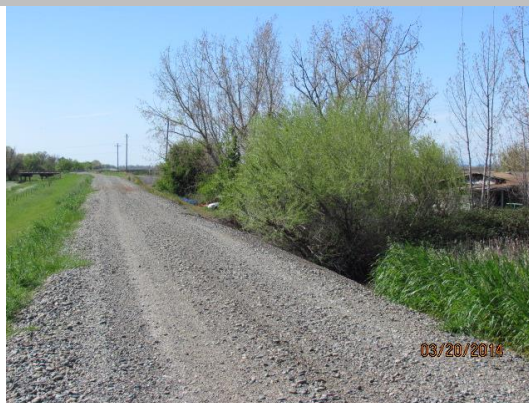
Photo 1 of 1 : SP\_2015\_MA0013\_300\_5\_20150310\_00003.jpg

Trim the trees along the landside slope and toe.

LM Start	9.70	Rating **	M	Issue No.	5
LM End	9.72	Issue Type +	Ma	Location *	LS
Category	Earthen Levee			GPS Latitude/Longitude	
				Start	End
Item	Trim / Thin Trees			39.467170 °	39.466860 °
				-121.743887 °	-121.744108 °
DWR ID	DWR_MA0013_01_s_2012_5				
Action/Comments					
Trim trees to at least five feet above ground level.

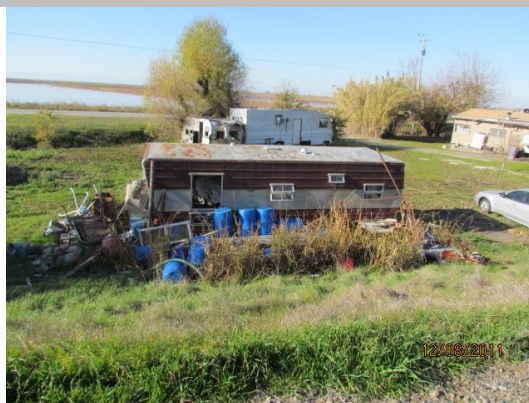
Photo 1 of 1 : SP\_2015\_MA0013\_300\_10\_20150310\_00005.jpg

View of a trailer &amp; material along the L/S toe.

LM Start	9.74	Rating **	M	Issue No.	10
LM End	9.74	Issue Type +	Ma	Location *	LS
Category	Earthen Levee			GPS Latitude/Longitude	
				Start	End
Item	Encroachments			39.466635 °	39.466635 °
				-121.744228 °	-121.744228 °
DWR ID	DWR_MA0013_01_f_2013_10				
Action/Comments					
Material

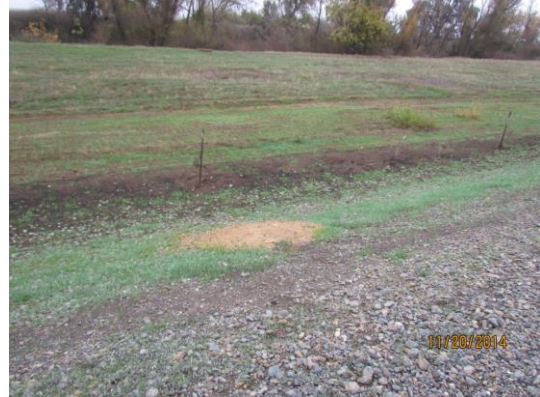
Photo 1 of 1 : SP\_2015\_MA0013\_300\_45\_20150310\_00012.jpg

View of the rodent hole on the waterside slope.

LM Start	15.02	Rating **	A/W	Issue No.	45
LM End	15.02	Issue Type +	Ma	Location *	WS
Category	Earthen Levee			GPS Latitude/Longitude	
				Start	End
Item	Animal Control			39.405542 °	39.405542 °
				-121.800392 °	-121.800392 °
DWR ID	DWR_MA0013_01_f_2014_45				
Action/Comments					
No rodents visible, but rodent burrows visible; need to backfill and compact or grout burrows.

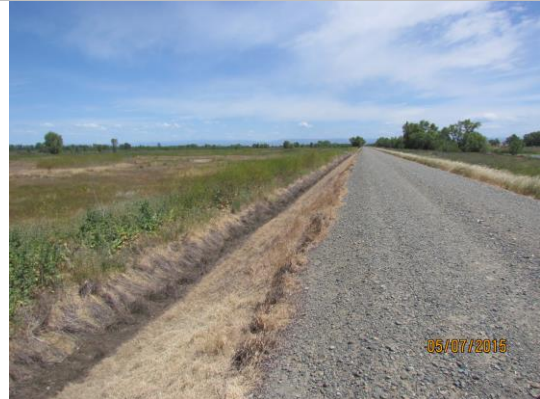
Photo 1 of 1 : SP\_2015\_MA0013\_300\_46\_20150519\_00015.jpg

View of no vegetation on the landside slope.

LM Start	17.09	Rating **	A	Issue No.	46
LM End	17.09	Issue Type +	Ma	Location *	LS
Category	Earthen Levee			GPS Latitude/Longitude	
				Start	End
Item	Vegetation			39.386423 °	39.386423 °
				-121.830107 °	-121.830107 °
DWR ID	DWR_MA0013_01_s_2015_46				
Action/Comments					
Control annual grass and weeds on the levee slopes and easements. Inspector Comments: Sutter Yard sprayed the vegetation from the landside slope.

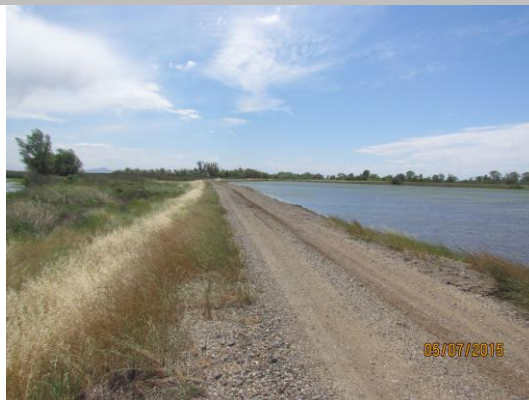
Photo 1 of 1 : SP\_2015\_MA0013\_301\_59\_20150519\_00023.jpg

View of the ruts in the crown roadway.

LM Start	3.88	Rating **	M	Issue No.	59
LM End	4.04	Issue Type +	Ma	Location *	CR
Category	Earthen Levee			GPS Latitude/Longitude	
				Start	End
Item	Crown Surface / Depressions / Rutting			39.524802 °	39.526697 °
				-121.701262 °	121.699680 °
DWR ID	DWR_MA0013_02_s _ 2015_59				
Action/Comments					
Repair depressions or ruts in the crown or slope.					
Inspector Comments: Repair the ruts in the crown roadway.

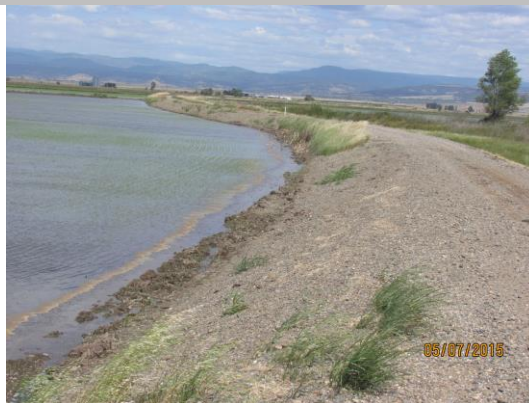
Photo 1 of 1 : SP\_2015\_MA0013\_301\_58\_20150519\_00022.jpg

View of the landside slope erosion that was caused by the water overtopping the levee.

LM Start	3.90	Rating **	M	Issue No.	58
LM End	4.04	Issue Type +	Ma	Location *	LS
Category	Earthen Levee			GPS Latitude/Longitude	
				Start	End
Item	Erosion / Bank Caving			39.524973 °	39.526697 °
				-121.701005 °	-121.699677 °
DWR ID	DWR_MA0013_02_s _ 2015_58				
Action/Comments					
Schedule repair of erosion site prior to the next inspection.					
Inspector Comments: Repaire the landside slope erosion.

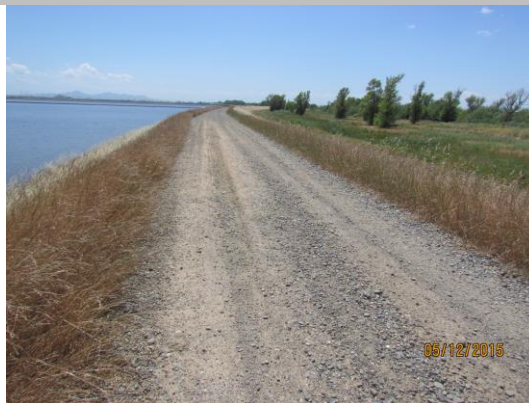
Photo 1 of 1 : SP\_2015\_MA0013\_301\_60\_20150518\_00015.jpg

View of the ruts in the crown roadway.

LM Start	7.46	Rating **	M	Issue No.	60
LM End	8.20	Issue Type +	Ma	Location *	CR
Category	Earthen Levee			GPS Latitude/Longitude	
				Start	End
Item	Crown Surface / Depressions / Rutting			39.503943 °	39.495120 °
				-121.716310 °	-121.724060 °
DWR ID	DWR_MA0013_02_s _ 2015_60				
Action/Comments					
Add appropriate material and re-grade the levee to bring the crown above the design elevation.					
Inspector Comments: Repair the ruts in the crown roadway.

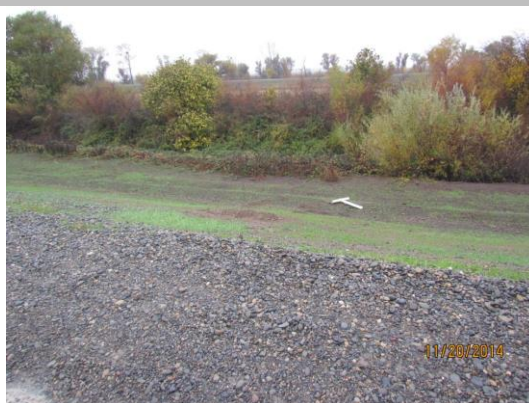
Photo 1 of 1 : SP\_2015\_MA0013\_301\_54\_20150310\_00012.jpg

View of the rodent holes and bait station along the waterside slope.

LM Start	16.52	Rating **	A/W	Issue No.	54
LM End	16.52	Issue Type +	Ma	Location *	WS
Category	Earthen Levee			GPS Latitude/Longitude	
				Start	End
Item	Animal Control			39.409548 °	39.409548 °
				-121.789668 °	-121.789668 °
DWR ID	DWR_MA0013_02_f _ 2014_54				
Action/Comments					
No rodents visible, but rodent burrows visible; need to backfill and compact or grout burrows.

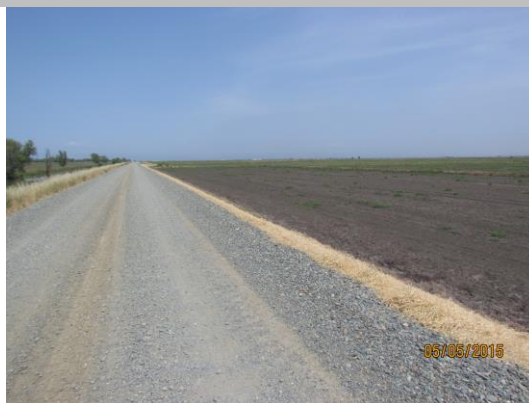
Photo 1 of 1 : SP\_2015\_MA0013\_301\_56\_20150519\_00021.jpg

View of no vegetation on the landside slope.

LM Start	18.87	Rating **	A	Issue No.	56
LM End	18.87	Issue Type +	Ma	Location *	LS
Category	Earthen Levee			GPS Latitude/Longitude	
				Start	End
Item	Vegetation			39.387780 °	39.387780 °
				-121.823445 °	-121.823445 °
DWR ID	DWR_MA0013_02_s _ 2015_56				
Action/Comments					
Control annual grass and weeds on the levee slopes and easements. Inspector Comments: Sutter Yard sprayed the vegetation along the landside slope.

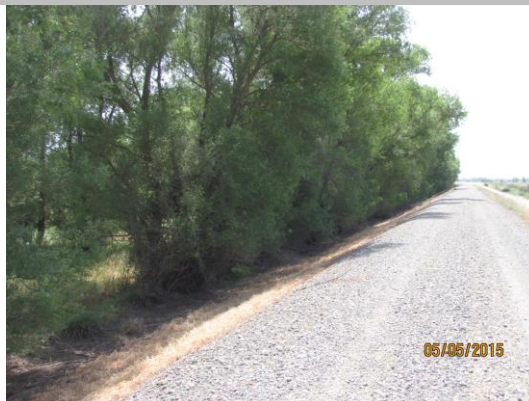
Photo 1 of 1 : SP\_2015\_MA0013\_301\_6\_20150519\_00019.jpg

Trim the trees 5 feet to allow visibility along the landside slope.

LM Start	20.48	Rating **	M	Issue No.	6
LM End	20.75	Issue Type +	Ma	Location *	LS
Category	Earthen Levee			GPS Latitude/Longitude	
				Start	End
Item	Trim / Thin Trees			39.372724 °	39.370732 °
				-121.846022 °	-121.850282 °
DWR ID	DWR_MA0013_02_s_2013_6				
Action/Comments					
Trim trees to at least five feet above ground level.					
Inspector Comments: Trim the trees 5 feet to allow visibility.

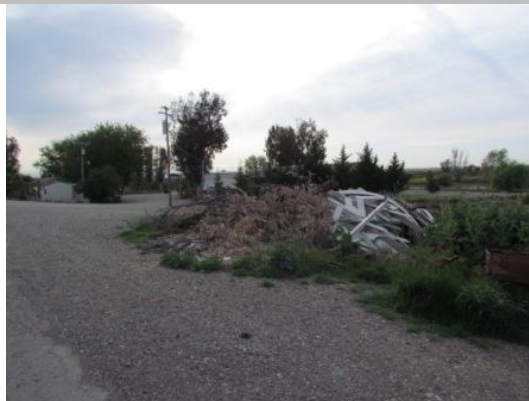
Photo 1 of 1 : SP\_2015\_MA0013\_301\_8\_20150310\_00004.jpg

View of the debris &amp; prunings.

LM Start	22.16	Rating **	M	Issue No.	8
LM End	22.16	Issue Type +	Ma	Location *	LS
Category	Earthen Levee			GPS Latitude/Longitude	
				Start	End
Item	Encroachments			39.359707 °	39.359707 °
				-121.872555 °	-121.872555 °
DWR ID	DWR_MA0013_02_s_2012_8				
Action/Comments					
Prunings

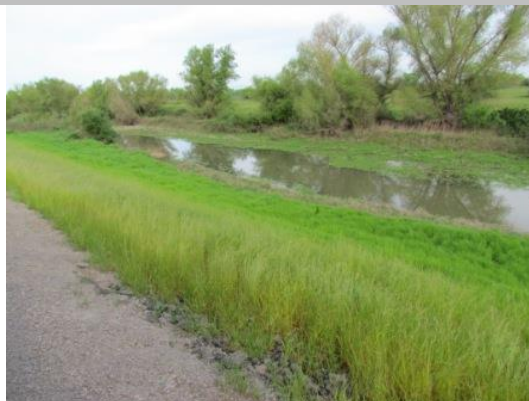
Photo 1 of 1 : SP\_2015\_MA0013\_301\_7\_20150310\_00003.jpg

View of the erosion along the canal.

LM Start	22.58	Rating **	M	Issue No.	7
LM End	22.60	Issue Type +	Ma	Location *	LS
Category	Earthen Levee			GPS Latitude/Longitude	
				Start	End
Item	Erosion / Bank Caving			39.356498 °	39.356303 °
				-121.879030 °	-121.879417 °
DWR ID	DWR_MA0013_02_s_2012_7				
Action/Comments					
Note and monitor erosion site.
